LIFE+

ANTI-COLLAPSING

Securing of floors

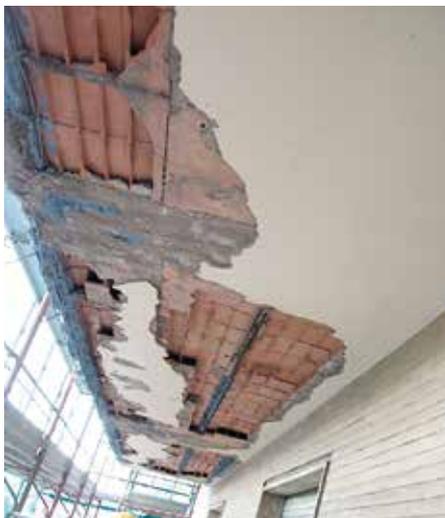
Issue

The term "collapsing" of the floor elements indicates the breaking and **detachment** of the intrados elements **of the hollow block slabs** used in the construction of brick and concrete ceiling slabs. The detachment of these elements from the ceiling is very dangerous, the sudden collapse of a portion of the floor involves the detachment of about $25 \div 40 \text{ kg/m}^2$ of material, up to 90 kg/m^2 . It concerns almost half of the schools and public buildings in Italy and in general, the buildings built between the 40s and 70s and is caused by **errors in the design, execution, choice of materials**, the **modification of the static conditions** of the ceiling slab, the **environmental conditions** and the **lack** of an adequate **maintenance** plan.

- cracks in the plaster
- signs of surface degradation (swelling, infiltration, etc.)
- partial detachments, even small ones

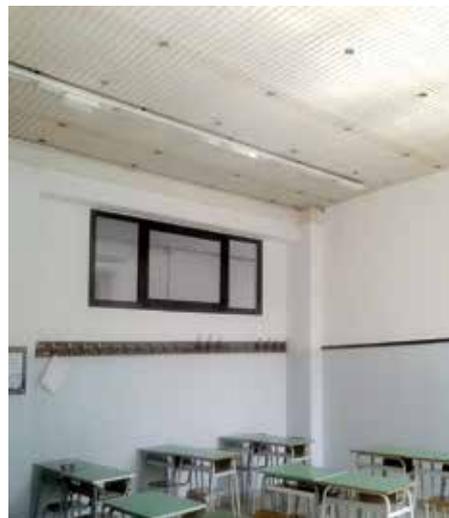
Solution

LIFE + is the system for securing brick and concrete, hollow-core concrete, steel or wood floors subject to the detachment of elements such as portions of plaster or hollow block elements (collapsing). It consists in the application of preformed in GFRP (Glass Fiber Reinforced Polymer) meshes fixed on the joists at the bottom of the floor through specifically dimensioned structural connection systems. An effective containment of the detachment is thus obtained. The system can be left exposed, plastered or covered with a false ceiling.
